## Enhanced Preliminary Assessment Report:

Addison Army Housing Units  
Addison, Illinois

November 1989

Environmental Research Division  
Argonne National Laboratory  
Argonne, Illinois 60439

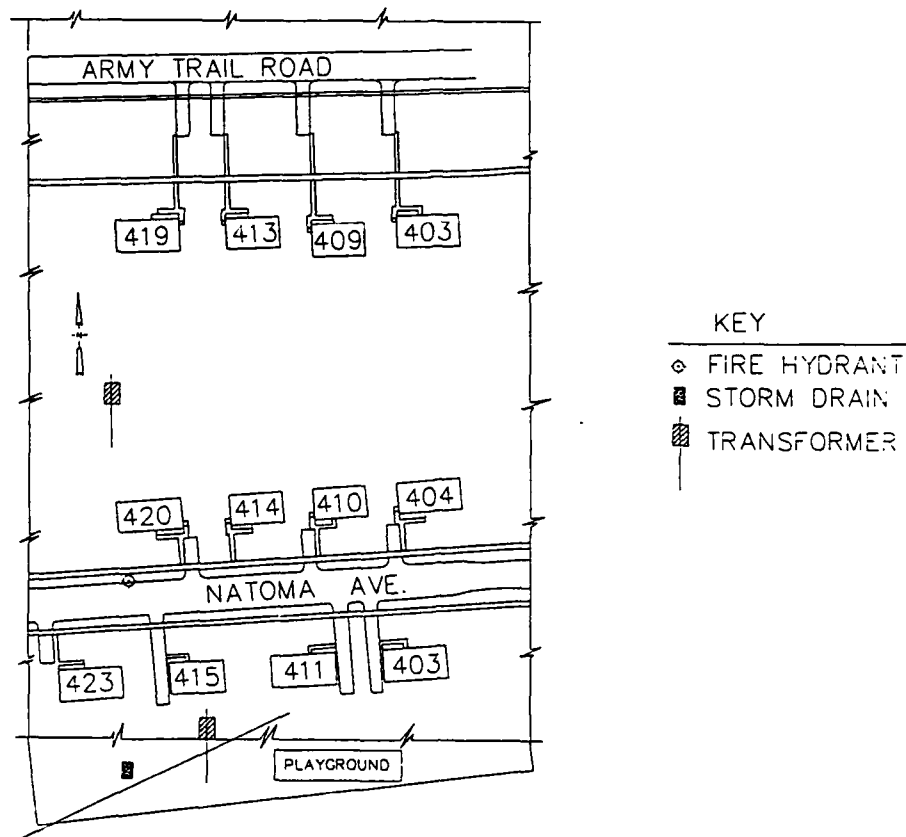
**FIGURE 3 Site Plan Map of Addison Army Housing Units**

It was reported that water stagnation occurs following rain storms in the lawn area situated between the two rows of houses; one row is on Army Trail Road and the other is on Natoma Avenue (see Fig. 3).<sup>4</sup> It was also reported that design work toward providing proper drainage of this area is in progress.<sup>4</sup>

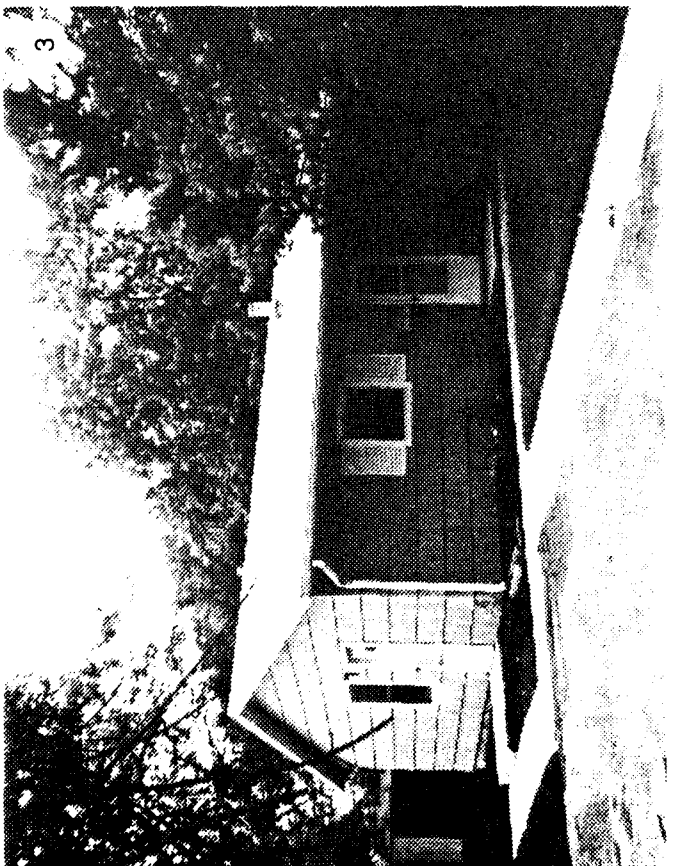
2

1. A view showing three of the four housing units on one row; there are three such rows of houses at this site.
2. Front view of one of the housing units, with parking area, and with storage shed at the rear.
3. Close-up view of another housing unit; front and side entrances to the house, and the down spout connected to the rain gutter, are seen.
4. The rear area between two rows of houses; storage sheds are in this area.
5. A playground for children; in the background, beyond the fence, are private residences.
6. Hot water heater and associated piping are shown here; insulation materials are not used around the heater and the pipes.
7. The furnace and air ducts shown here again evidence the absence of insulation materials.
8. Utility pole with a transformer mounted near the top; transformers at this site are owned and maintained by the U.S. government.
